Manhole Inspection Summary

Manhole # S23GG1027MH

Insp Date: **12/11/06 1:54 PM**

Location Address: **4103 EDGEHILL AVE**

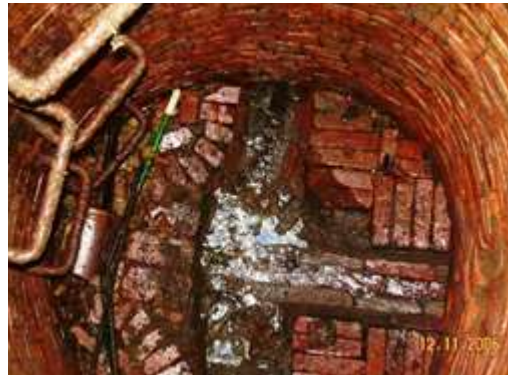
Top View

Corroded steps. Bench deterioration and cracks. Evidence of surcharge - Bench debris. Channel debris.

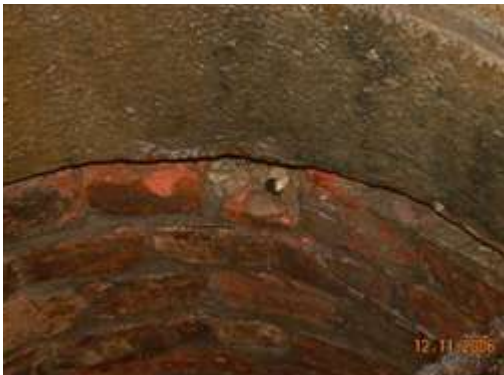
Defect

Frame leaks. Adjustment deterioration and infiltration.

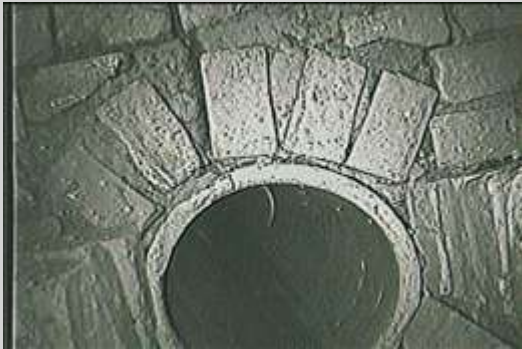
8 in. Circular Gravity Sewer Pipe Out @ 12 O'Clock

Infiltration: **Evidence** Pipe Seal Cond: **Cracked**

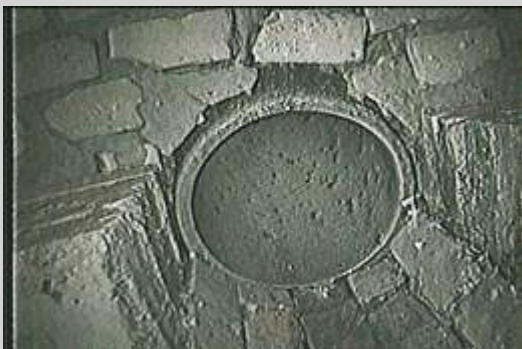
8 in. Circular Gravity Sewer Pipe In @ 3 O'Clock

Barrel deterioration and infiltration. Channel deterioration.

Infiltration: **Evidence** Pipe Seal Cond: **Broken**

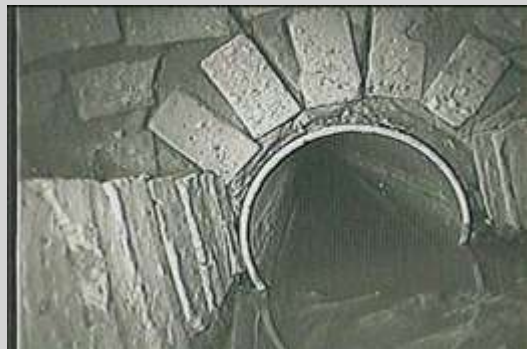
Pipe In @ 6 O'Clock

Infiltration: **Evidence**

Pipe Seal Cond: **Broken**
